REPORT OF THE 1912 INSPECTION OF THE ATLANTIC CITY WOODEN TEST FENCE,

INCLUDING THE REPAINTING TESTS AND THE NEW TESTS.

SCIENTIFIC SECTION
HENRY A. GARDNER, Director

EDUCATIONAL BUREAU
PAINT M'F'RS ASSOCIATION OF THE UNITED STATES
PHILADELPHIA, PA.

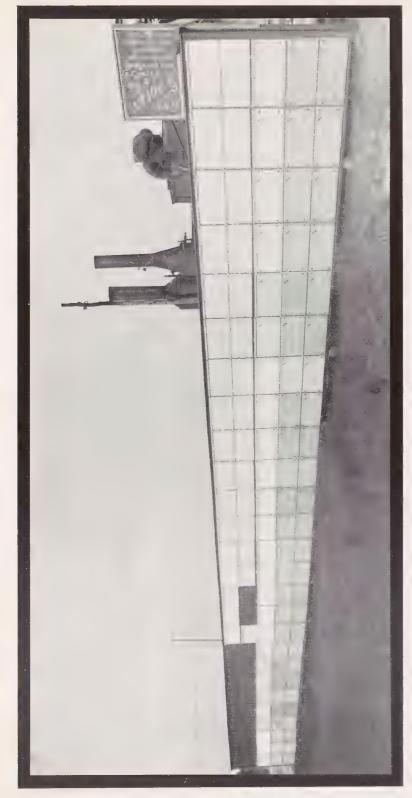
VIEW OF TEST FENCE, AUGUST 30, 1912.

Present arrangement of panels shown. End of fence is shown cut off where destroyed by railroad. Road binder plant shown in back of fence.

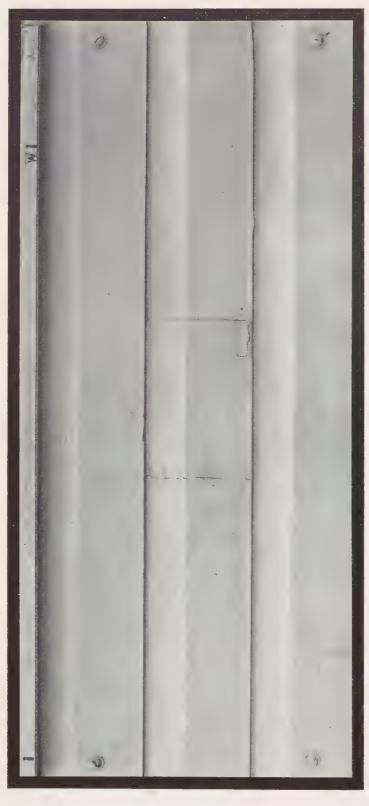
Test Panel No. 1

Results of Inspection, Aug. 30, 1912: Chalking: Very slight Checking: Slight General Condition: Very good

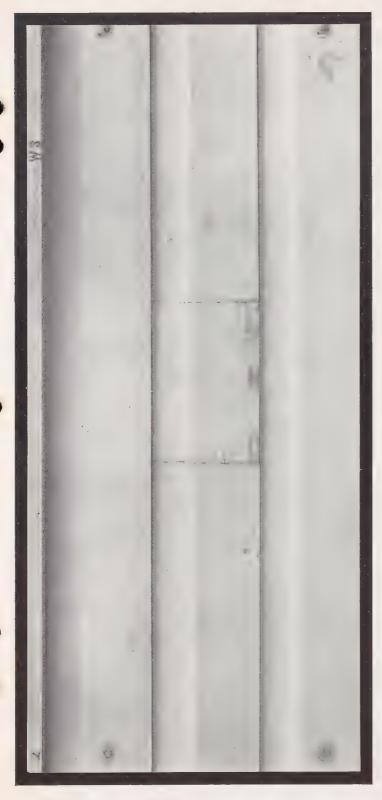
Test Panel No. 3

Results of Inspection, Aug. 30, 1912; Chalking: Very slight Checking: Slight General Condition: Very good

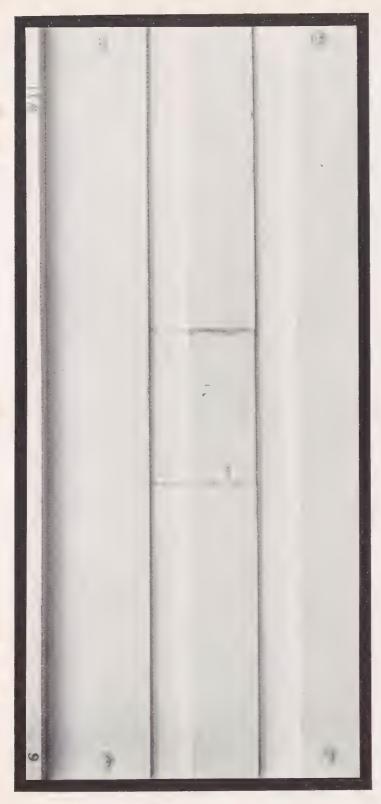
Test Panel No. 11

Results of Inspection, Aug. 30, 1912:
Chalking: Medium
Checking: Slight
General Condition: Fairly good
 Zinc Oxide
 64%

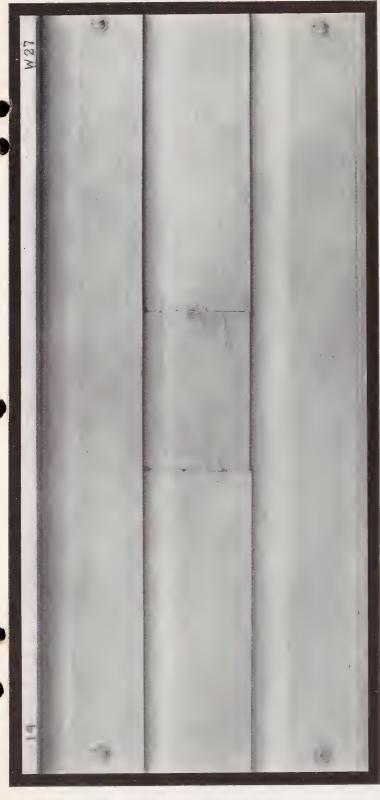
Test Panel No. 27

Results of Inspection, Aug. 30, 1912: Chalking: Medium Checking: Slight General Condition: Fair Basic Carbonate-White Lead. 25% Zmc Oxide. 25% Basic Sulphate-White Lead. 20% Calcium Carbonate. 5% Calcium Sulphate.

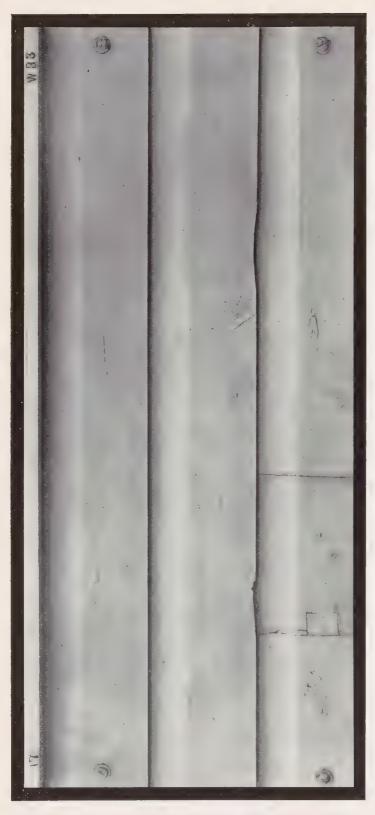
Test Panel No. 33

Results of Inspection, Aug. 30, 1912: Chalking: Considerable Checking: Medium General Condition: Fairly good
40% 40% 3% 13% 4%
Basic Carbonate-White Lead 40% Results of Inspection. Aug. 30, 1912: Zinc Oxide

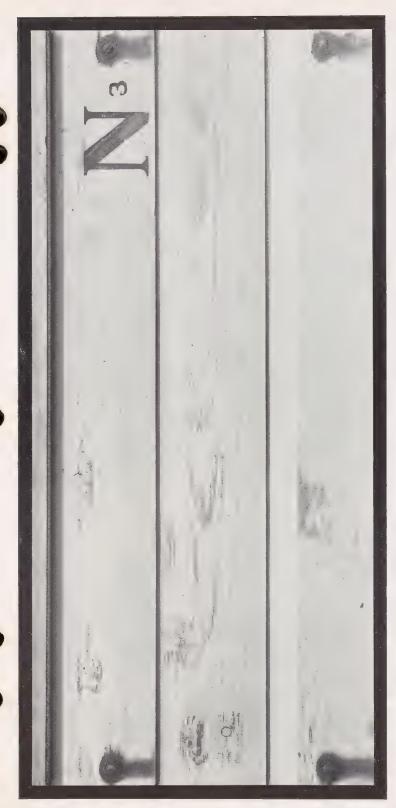
Formula No. 3

Results of Inspection, Aug. 30, 1912:	Chalking: Considerable	Checking: Disintegrated	General Condition: Poor	
Zine Oxide	Lithopone	Calcium Carbonate		100%

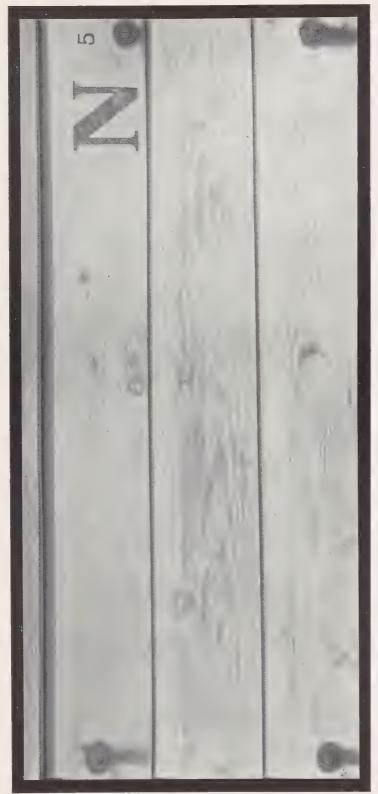
Test Panel No. 5

Results of Inspection, Aug. 30, 1912; Chalking: Considerable Checking: Disintegrated General Condition: Poor
 Zinc Oxide.
 40%

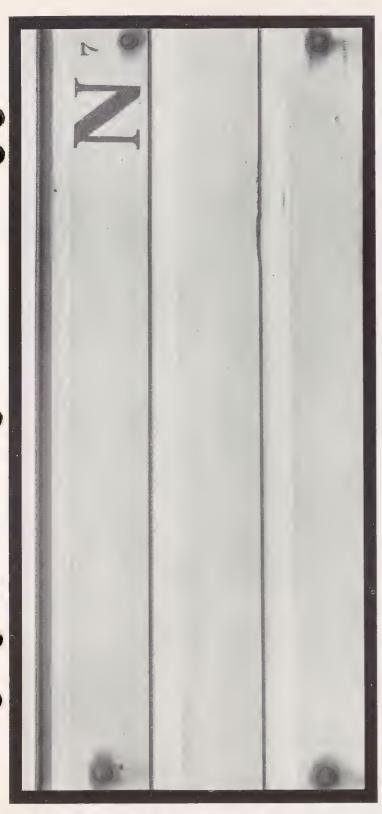
Test Panel No. 7 Formula No. 7 NEW TESTS

Results of Inspection, Aug. 30, 1912; Chalking: Considerable Checking: Very slight General Condition: Good Basic Carbonate-White Lead. 50%
Zinc Lead. 36%
Asbestine China Clay. 2%
Barytes 4%

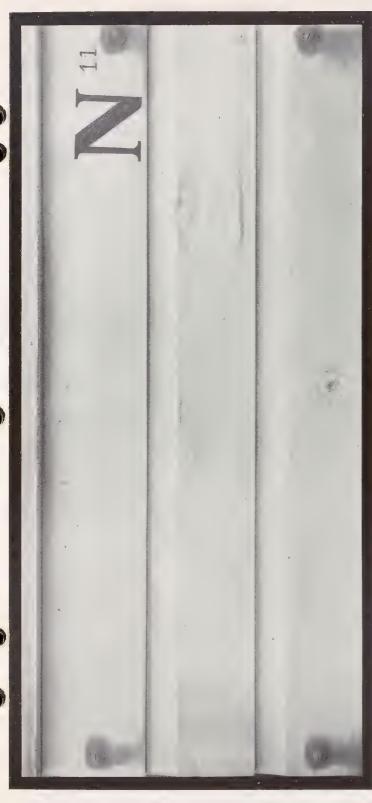
New Tests Formula No. 11 Test Panel No. 11

Results of Inspection, Aug. 30, 1912:
Chalking: Slight
Checking: Considerable
General Condition: Fair to poor

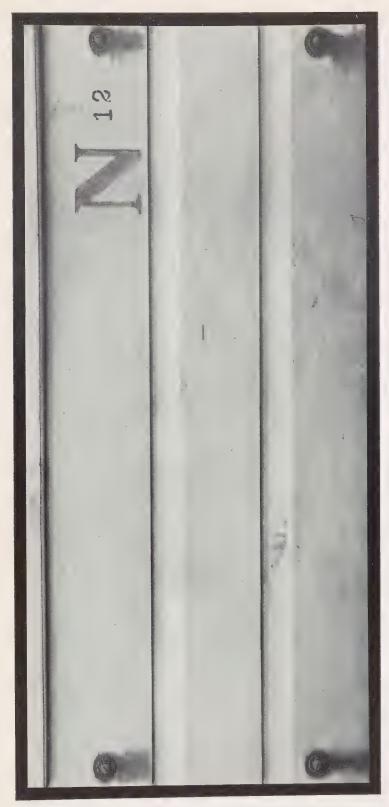
Results of Inspection, Aug. 30, 1912:	Chalking: Considerable	Checking: Slight	General Condition: Good		
25%	28%	3%	1%	1%	
Zinc Oxide	Basic Sulphate-White Lead	Asbestine	Barytes	Blanc Fixe

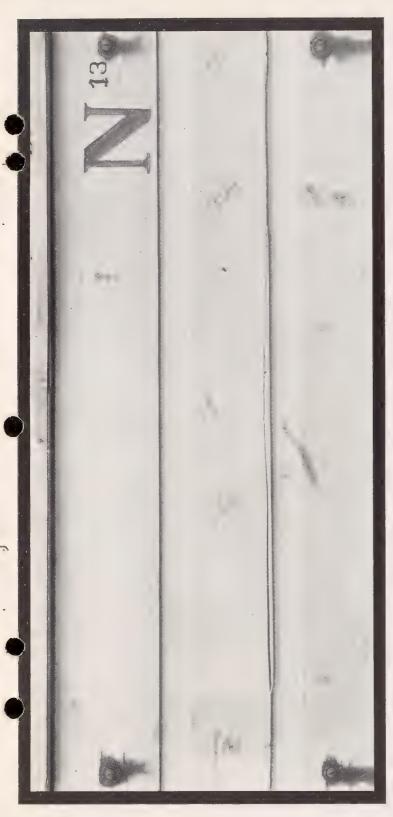
Test Panel No. 13

Results of Inspection, Aug. 30, 1912: Chalking: Medium Checking: Considerable General Condition: Fair to poor
 Zinc Oxide
 60%

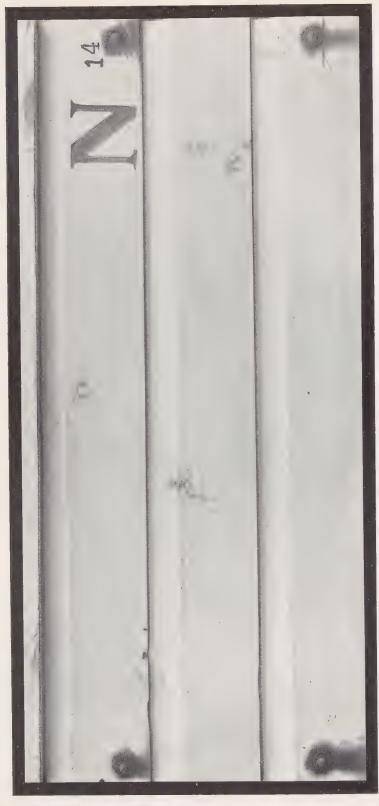
Test Panel No. 14

Chalking: Heavy Checking: Considerable General Condition: Fair to poor Results of Inspection, Aug. 30, 1912; Lithopone Carbonate....

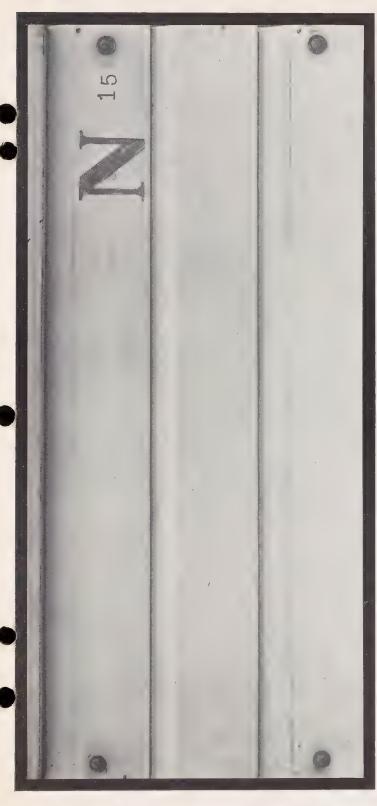
Test Panel No. 15

Results of Inspection, Aug. 30, 1912:
Chalking: Heavy
Checking: Heavy
General Condition: Fair

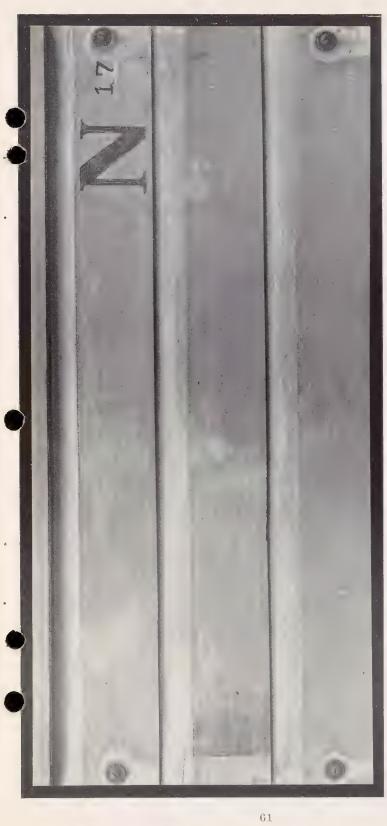
Test Panel No. 17

...... 100% Results of Inspection, Aug. 30, 1912:
Chalking:
Checking:
General Condition: Disintegrated

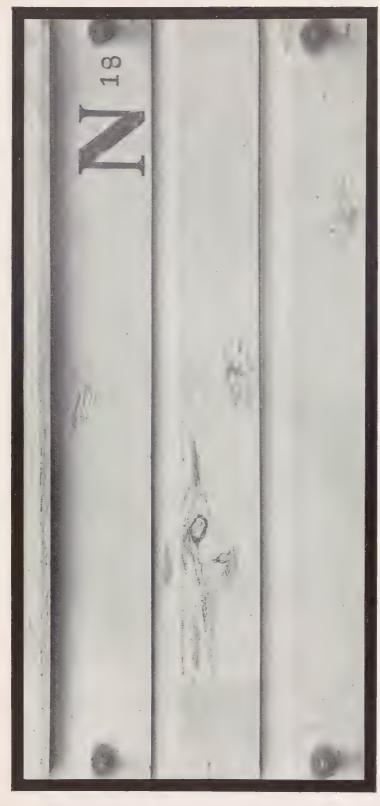
Test Panel No. 18

Chalking: Slight Checking: Slight General Condition: Fair Results of Inspection, Aug. 30, 1912: Basic Carbonate-White Lead. 33% Zinc Oxide. 33% Silica 117% China Clay.

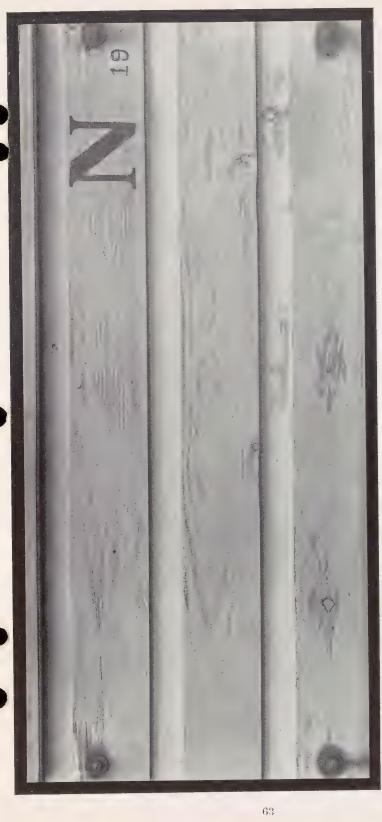
Formula No. 19 NEW TESTS

l No. 19	Results of Inspection, Aug. 30, 1912: Chalking: Slight Checking: Disintegrated General Condition: Poor
Test Panel No. 19	Basic Carbonate-White Lead. 34% Zinc Oxide. 33% Silica 33%

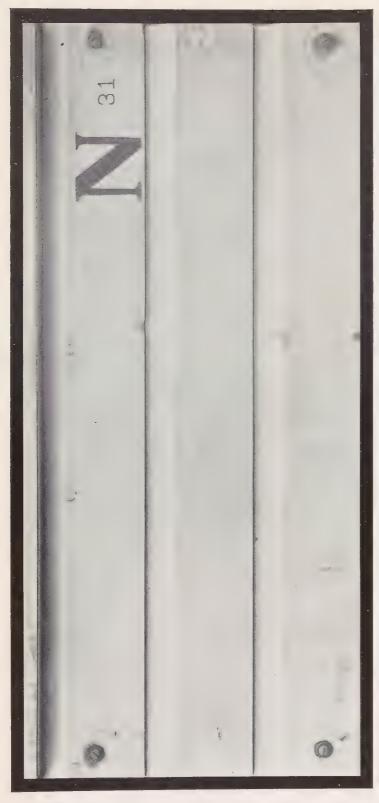
Test Panel No. 31

Results of Inspection, Aug. 30, 1912; Chalking: Heavy	Checking: Heavy alligatoring	
45% 40%	15%	100%
Basic Carbonate-White Lead. 45% Lithopone 40%	Silica

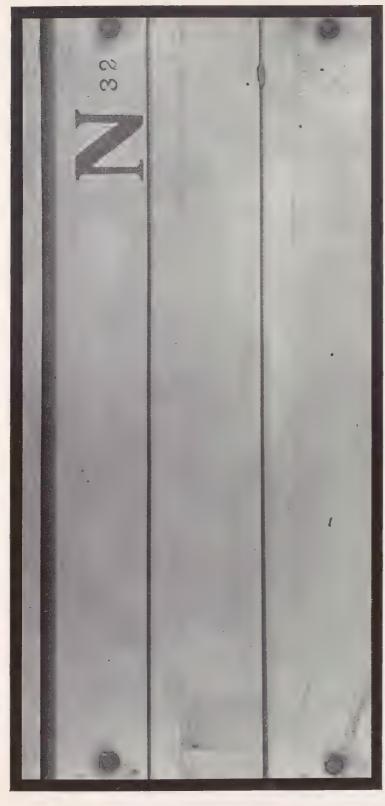
Test Panel No. 32

Results of Inspection, Aug. 30, 1912:
Chalking: Heavy
Checking: Heavy
General Condition; Poor

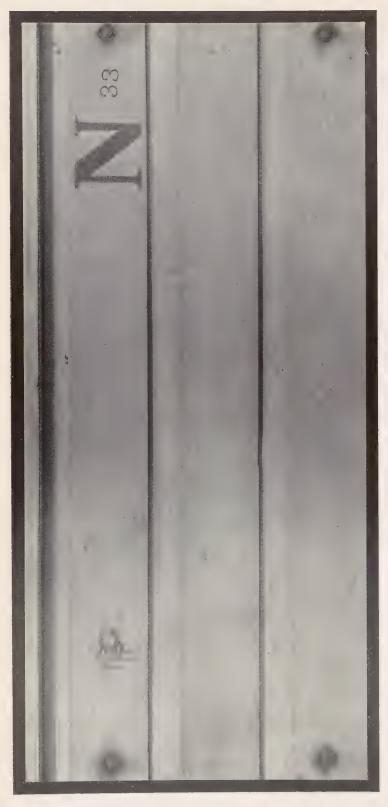
Test Panel No. 33

Results of Inspection, Aug. 30, 1912: Chalking: Considerable Checking: Slight General Condition: Poor Basic Carbonate-White Lead. 50% Lithopone 36% Asbestine 2% Barytes 12% 100% Barytes

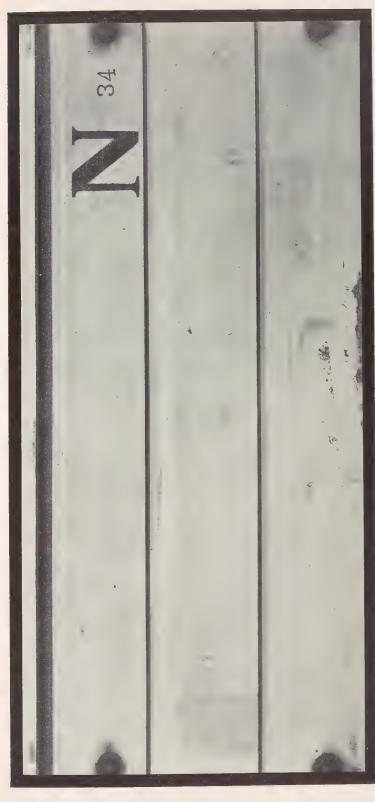
Test Panel No. 34

Results of Inspection, Aug. 30, 1912: Chalking: Heavy Checking: Considerable General Condition: Fair 100%

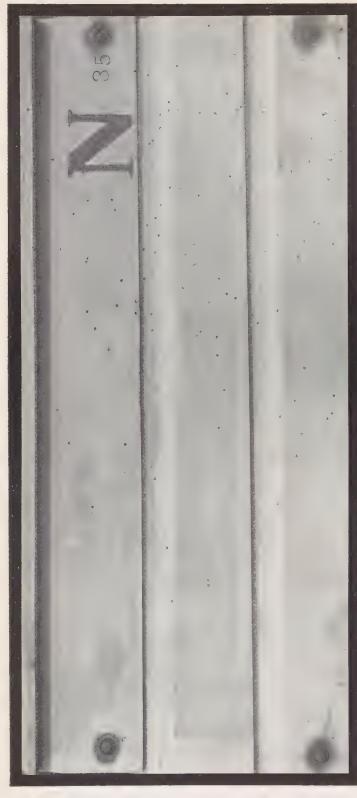
Test Panel No. 35

Results of Inspection, Aug. 30, 1912: Chalking: Considerable Checking: Slight General Condition: Fair 100%
